DOT/FAA/AR-00/22

Corrosion and Corrosion Fatigue of Airframe Materials

July 2000

Final Report

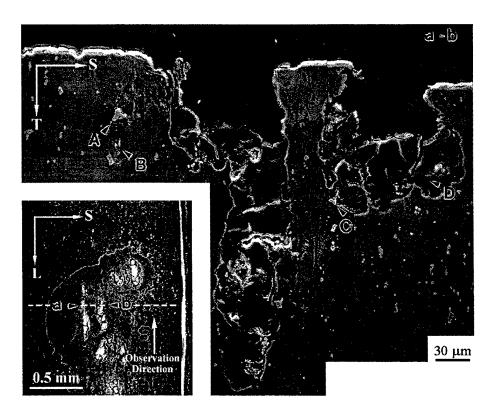
Figure 3-2 shows SEM micrographs of the cross section of pits formed from such clusters of constituent particles and an inset of the pits at the specimen surface [5,6]. The larger of the two pits is approximately 500 µm long and 70 µm wide at the surface and approximately 300 µm deep at this section. The overall shape of the pit reflects the planar distribution of constituent particles in this alloy. A comparison of the deeper severe pit in figure 3-2 with the SEM microfractograph of a fatigue crack origin (a corrosion pit represented by the dark region at the center of the microfractograph) in figure 3-3 shows that their overall features are nearly identical. The associated surface features of the fatigue origin (not shown) are also identical to those shown in the inset in figure 3-2. Similar comparisons clearly identify severe localized pits as nuclei for corrosion fatigue cracking.

FIGURE 3-2. SEM MICROGRAPH OF THE CROSS SECTION OF SEVERE CORROSION PITS IN A 2024-T3 ALUMINUM ALLOY (TS) SURFACE ALONG WITH AN INSET SHOWING THE APPEARANCE OF THE CORRESPONDING PITS ON THE LS SURFACE

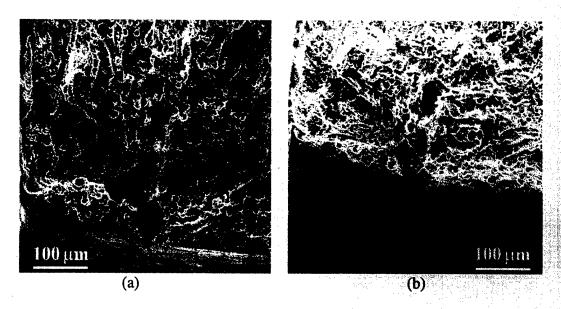
FIGURE 3-3. SEM MICROFRACTOGRAPHS OF FATIGUE FRACTURE SURFACE OF A 2024-T3 ALLOY SHOWING A SEVERE CORROSION PIT AS THE CRACK NUCLEUS: VIEWED (a) NORMAL AND (b) AT 45° TO THE FRACTURE SURFACE

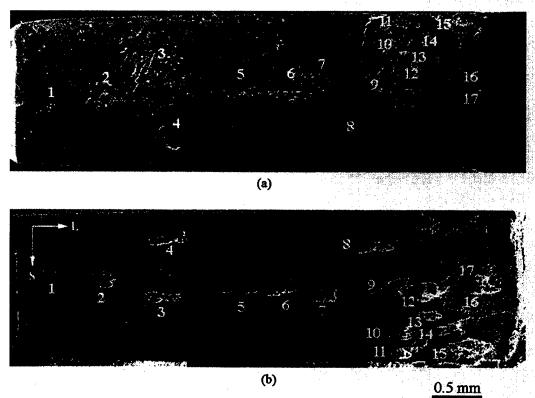
FIGURE 3-4. SEM MICROGRAPHS SHOWING SEVERE PITTING IN A 2024-T3 ALUMINUM ALLOY AFTER 500 HOURS IN 0.5M NaCl SOLUTION AT ROOM TEMPERATURE: (a) THE LS SURFACE AFTER CHEMICAL CLEANING AND (b) THE CORRESPONDING 3D REPLICA [6]

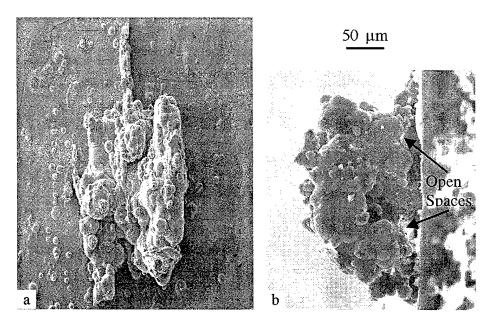
SEM micrographs of the replica of pit 2, in plan and side views, are shown at a higher magnification in figure 3-5. Figure 3-5 shows the typically complex form of a severe corrosion pit. The appearance of the replica is consistent with the postulated role of constituent particles in promoting pitting corrosion in the high-strength aluminum alloys. The individual rounded features are believed to correspond to galvanic corrosion of the matrix by the cathodic constituent particles in the alloy, and the overall planar appearance is attributed to the planar array of these particles in the rolled sheet. The open space seen in figure 3-5(b) suggests the role corrosion played around a particle (or a cluster of particles) at the surface in allowing the electrolyte to penetrate into the alloy and effect substantial corrosion beneath the surface. The 3D nature of these pits is best seen through the use of stereo imaging techniques (not shown here). The shape of the replica for pit 2 might be likened to that of one-half of a pecan or walnut with the center representing the small pit opening at the surface and the rest the cavernous pit below the surface.

FIGURE 3-5. SEM MICROGRAPHS OF THE EPOXY REPLICA OF A SEVERE CORROSION PIT IN 2024-T3 ALUMINUM ALLOY: (a) PLAN (BOTTOM) AND (b) ELEVATION (SIDE) VIEW RELATIVE TO THE ORIGINAL PIT

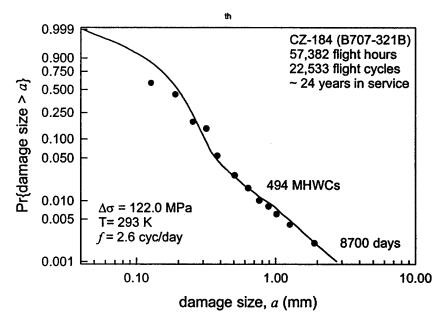
FIGURE 7-3. A COMPARISON BETWEEN THE PREDICTED AND OBSERVED PoO FOR HOLE-WALL DAMAGE IN THE LEFT-HAND LOWER WING SKINS (2024-T3 ALUMINUM ALLOY) OF THE CZ-184 AIRCRAFT

Based on reasonable values of localized corrosion and corrosion fatigue crack growth rates and by considering the primary loading from ground-air-ground (adjusted for average gust loading) cycles, the PoO of damage is estimated for each aircraft and is shown as a solid line in each of the figures. For the skins, the agreement is very encouraging. It suggests that it is feasible to estimate service performance quite well on the basis of laboratory data provided that the predictive methodology is based upon reasonable mechanistic models. On the other hand, the

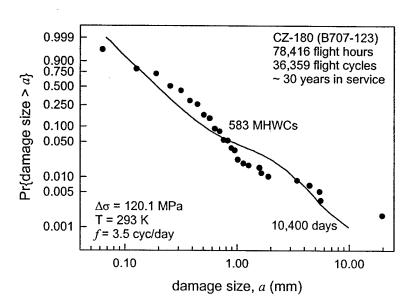
FIGURE 7-4. A COMPARISON BETWEEN THE PREDICTED AND OBSERVED PoO FOR HOLE-WALL DAMAGE IN THE LEFT-HAND LOWER WING STIFFENERS (7075-T6 ALUMINUM ALLOY) OF THE CZ-180 AIRCRAFT

agreement for the stiffeners is not as good. There are a variety of reasons for the discrepancy. The aluminum alloy for the stiffeners is 7075-T651, for which the experimental data needed to estimate the model parameters accurately is more limited than that for the 2024-T3 alloy used for the skins. The stiffeners are typically thicker than the skin, and the model may need to be Stresses may be sufficiently different in the stiffeners so that adjusted accordingly. improvements in the crack growth portion of the model may be required. The assumption of hemispherical growth of the corrosion pits may be inappropriate. It also should be noted that the model is based upon a single (dominant) damage and the measurements reflected a single value for each location; whereas, multiple cracks were observed for the fastener holes in the skins and the stiffeners. This aspect will be discussed further in relation to the metallographic examination. Consequently, further experimental testing and modeling is warranted for this application. Nevertheless, the maximum deviation from the empirical data and the estimated PoO is less than 9% for CZ-180, which may be reasonable for predictions. The maximum deviation for CZ-184, however, is at best about 21%. On the other hand, there is some error incurred from the J-STARS observation method.

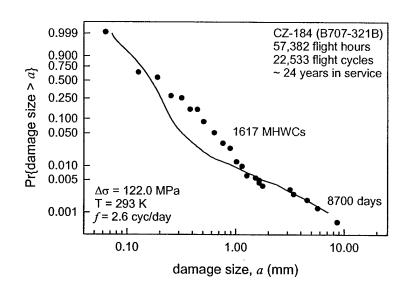
FIGURE 7-5. A COMPARISON BETWEEN THE PREDICTED AND OBSERVED PoO FOR HOLE-WALL DAMAGE IN THE LEFT-HAND LOWER WING STIFFENERS (7075-T6 ALUMINUM ALLOY) OF THE CZ-184 AIRCRAFT

The uncertainty in measurement for the stiffeners may be estimated from available data on the skins. For 42 selected fastener holes from the CZ-184 skin, the crack lengths were estimated by employing higher resolution optical microscopy, described below, and the average relative difference exceeds 75%. Figure 7-6 duplicates figure 7-5 with the addition of error bars for the reported crack lengths, assuming that the measurement error was 50%. This leads to a relatively broad error band for the data. For this scenario the predicted PoO falls within all of the error bounds. Even so, the prediction does not appear to be satisfactory. Again, further analyses are warranted. Thus, the viability of the model for estimating the PoO has been established in terms of the reported teardown data for the wing skins, but caution must be exercised for the stiffeners.

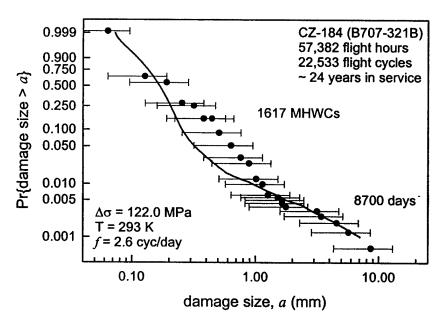
FIGURE 7-6. A COMPARISON BETWEEN THE PREDICTED AND OBSERVED PoO WITH ESTIMATED ERROR BARS FOR THE DATA FOR HOLE-WALL DAMAGE IN THE LEFT-HAND LOWER WING STIFFENERS OF THE CZ-184 AIRCRAFT

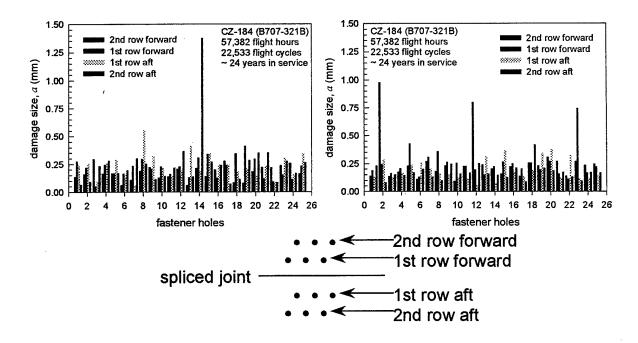
The availability of a validated predictive model for PoO provides a rational method for estimating the distribution of damage for use in MSD analyses. The approach and methodology is illustrated by using the predicted PoO distribution for the CZ-184 aircraft, see figure 7-3. Using Monte Carlo simulation for the largest crack length in each fastener hole, the damage distribution for a collection of fastener holes may be estimated. Damage from hole to hole, as well as at the two highly stressed sides of each hole, is considered to be statistically independent. Two such distributions, each representing one simulation, are shown in figure 7-7 for 100 fastener holes arranged in four rows along a spliced joint. Each simulation may represent different locations in a single aircraft or the same location for different aircraft under comparable service conditions. From these figures, it is seen that different levels of damage are possible, and critical locations may be identified through the size and clustering of damage at a given stage in service. To illustrate the effect of considering larger populations of holes, a simulation for 1,000 holes is shown in figure 7-8. Note that the extreme values, i.e., larger size damage, in the distribution are considerably more prominent, and a number of critical areas can be identified readily. These illustrations demonstrate the value of this approach in airworthiness assurance and management of civil and military aircraft.

FIGURE 7-7. VARIATIONS IN THE SIMULATED DAMAGE DISTRIBUTIONS FOR 100 FASTENER HOLES BASED ON THE PoO FOR THE SKIN OF THE CZ-184 AIRCRAFT

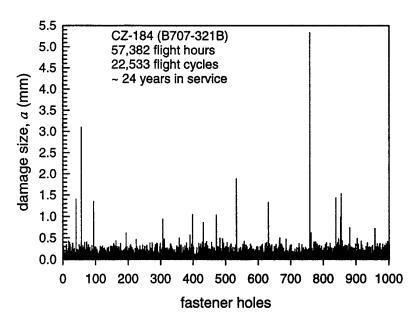
FIGURE 7-8. SIMULATED DAMAGE DISTRIBUTION FOR 1,000 FASTENER HOLES BASED ON THE POO FOR THE SKIN OF THE CZ-184 AIRCRAFT

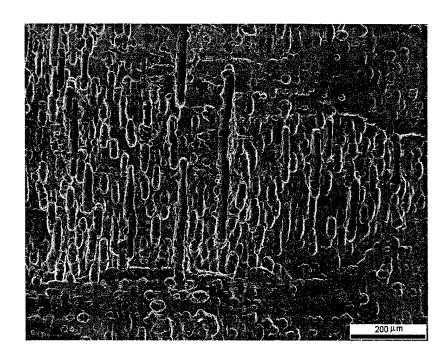
FIGURE 7-9. SEM MICROGRAPH OF CORROSION-RELATED DISTRIBUTED DAMAGE AT HOLE NO. 54 IN PANEL B2-2-2 OF THE CZ-184 AIRCRAFT

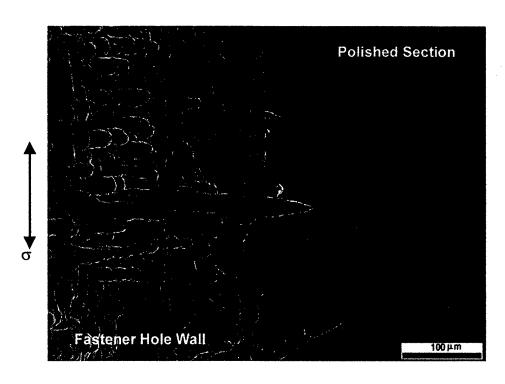
FIGURE 7-10. SEM MICROGRAPH OF A SECTION THROUGH AN ELONGATED DAMAGE AT HOLE NO. 77 IN WING PANEL B3-2-5 OF THE CZ-184 AIRCRAFT SHOWING CORROSION ATTACK OF THE FATIGUE CRACK

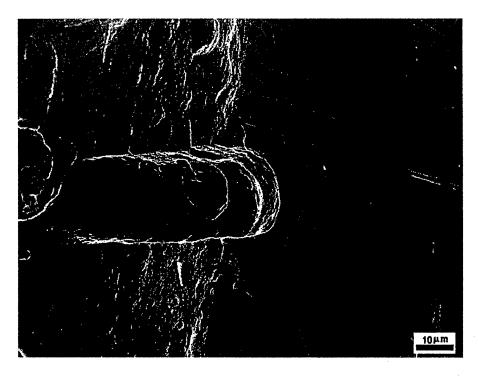
FIGURE 7-11. SEM MICROGRAPH OF A THROUGH SECTION OF A SHALLOW DAMAGE AT HOLE NO. 77 IN WING PANEL B3-2-5 OF THE CZ-184 AIRCRAFT SUGGESTING THAT THE CRACK WAS DISSOLVED BY CORROSION

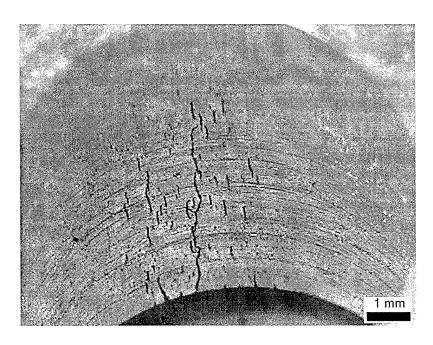
FIGURE 7-12. OPTICAL MICROGRAPH OF A HIGHLY STRESSED REGION OF HOLE NO. 107 IN WING PANEL B3-2-2 OF THE CZ-184 AIRCRAFT SHOWING EXTENSIVE CORROSION FATIGUE CRACKING

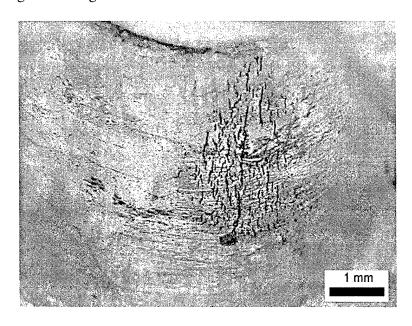
FIGURE 7-13. OPTICAL MICROGRAPH OF A HIGHLY STRESSED REGION OF HOLE NO. 103 IN WING PANEL B3-2-2 OF THE CZ-184 AIRCRAFT SHOWING EXTENSIVE CORROSION FATIGUE CRACKING

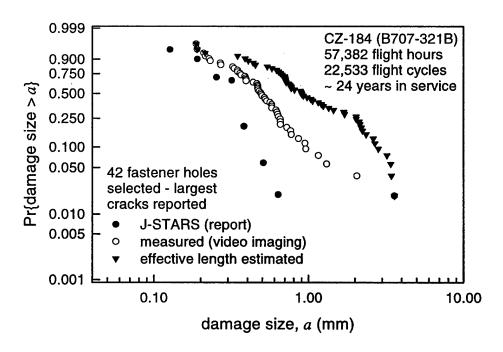
The first issue to consider is the accuracy of the values in the J-STARS report. As mentioned above, a large number of holes were inspected, but with only a 20× magnifying lens. This activity is very tedious and probably not especially accurate based on the magnification and the difficult angles required to view the cracks. Figure 7-14 shows the damage sizes for 42 holes that were selected because the J-STARS report indicated MHWCs of significant length. The graph also includes the sizes measured with the aid of the Hi-Scope video imaging system at a magnification of 50 to 150× described above and estimated effective crack lengths to capture the entirety of the damage region. Clearly, there are significant differences between the three data sets. In fact, the average value for each of the three sets is 0.36 mm (0.014 in), 0.61 mm (0.024 in), and 1.43 mm (0.056 in), respectively. The range of the data, from left to right, increases indicating greater scatter. This may be an artifact of the methodologies in that the data from the J-STARS report are grouped, and the estimation of effective lengths was somewhat subjective (see, for example, figure 7-13). Nevertheless, the overriding conclusion is that, if possible and feasible, higher-resolution microscopy is needed to accurately characterize the damage in fastener holes.

FIGURE 7-14. COMPARISON OF THE PoO FOR THE MAXIMUM MHWC LENGTHS REPORTED BY J-STARS, MEASURED USING VIDEO IMAGING MICROSCOPY, AND EFFECTIVE LENGTH ESTIMATED FROM THE OVERALL EXTENT OF THE FIELD OF DAMAGE FOR SELECTED HOLES FROM THE CZ-184 AIRCRAFT

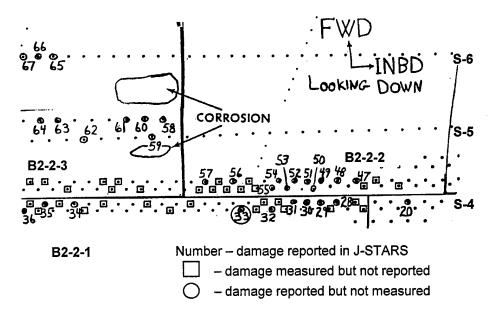
In an attempt to complete a carefully formulated statistical analysis for a significant number of fastener holes, 110 holes from B2-2 along S-4 were observed with the Hi-Scope system. Figure 7-15 is taken from figure B2-2 in [18]. The holes considered are those in the two rows forward and aft of the spliced joint in panels B2-2-1 to B2-2-3. The holes that have been circled and numbered are those in which damage was observed by the J-STARS analyses. Thirty-two additional holes with damage, circumscribed by a square, were found to have damage using the Hi-Scope, but were not included in the J-STARS report. Hole No. 33 was reported to have damage, but none was found in the Hi-Scope examination. Clearly, the fraction of holes with damage in this section along this stiffener is quite high, with 51 out of the 110 holes (not including #33) having experienced damage. A contributing factor to this observation is that steel fasteners were used with 2024-T3 aluminum alloy skin along S-4. Galvanic coupling between the fasteners and the skin, in the presence of a deleterious environment, would enhance the nucleation and growth of corrosion. In passing, notice that J-STARS inspectors highlighted two patches of corrosion observed on the surface of the skin.

FIGURE 7-15. A PORTION OF SECTION 2 ALONG STIFFENER 4 FROM THE CZ-184 AIRCRAFT FOR WHICH MICROSCOPY AND STATISTICAL ANALYSES ARE MADE

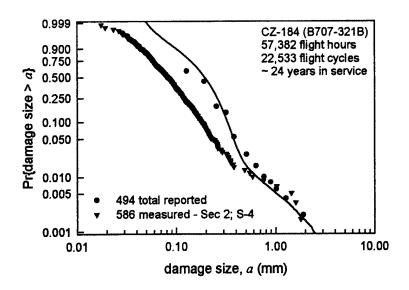
Figure 7-16 shows the empirical PoO from the J-STARS report, the predicted PoO for that data, and the empirical PoO for the MHWCs from the 110 holes shown in figure 7-15. Since the new data lie to the left of the other, the position of the solid line suggests that it overestimated distribution and severity of damage, although the actual extent of damage was greater in terms of the number of fastener holes affected. The discrepancy reflects principally the difference in measurement resolution and secondarily measurement procedure. In the J-STARS examinations, the smallest value reported was a = 0.127 mm for all of the panels, whereas the new measurements were as small as a = 0.015 mm. Also, the J-STARS report included only the "largest" crack found on each side of a hole. The new measurements, on the other hand, considered every resolvable crack in each hole along S-4 in panel B2-2. Consequently, care should be exercised in the application of the proposed model.

FIGURE 7-16. COMPARISON OF THE PoO FOR ALL MHWC LENGTHS REPORTED BY J-STARS AND ALL OF THOSE MEASURED USING VIDEO IMAGING MICROSCOPY FOR 110 HOLES FROM SECTION 2 ALONG STIFFENER 4 FROM THE CZ-184 AIRCRAFT

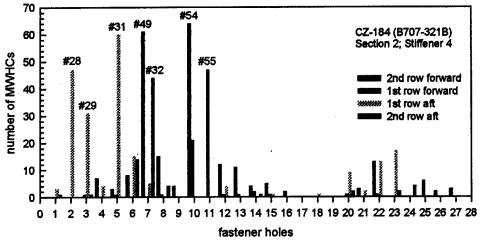
Figure 7-17 shows the density of the MHWCs for the 110 holes along S-4 shown in figure 7-15, obtained using video imaging microscopy. The holes are numbered right to left, similar to the J-STARS enumeration; however, each of the four rows are numbered separately. The holes with the most severe damage are also labeled for easy reference. There are three holes with at least 60 cracks and another three with at least 40. Furthermore, all six of these holes are rather close, as indicated on figure 7-15. Figure 7-18 shows a plot of the largest measured cracks along S-4. The pattern is similar to the estimated distributions shown in figures 7-7 and 7-8 and attests to the efficacy of the approach for estimating MSD. It is also closely related to the numbers of cracks per fastener hole shown in figure 7-17 and suggests the potential link-up of the MHWCs leading to MSD.

FIGURE 7-17. DENSITY OF MEASURED CRACKS PER FASTENER HOLE FOR SECTION 2; STIFFENER 4 FROM THE CZ-184 AIRCRAFT

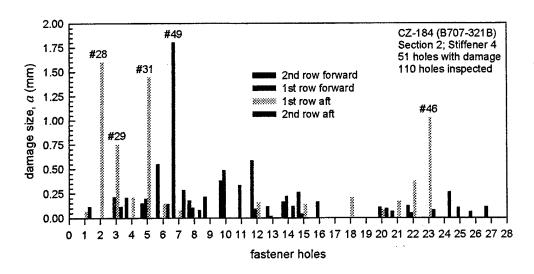
FIGURE 7-18. DAMAGE DISTRIBUTION OF MAXIMUM CRACK LENGTHS FOR 110 FASTENER HOLES FROM SECTION 2 ALONG STIFFENER 4 FROM THE CZ-184 AIRCRAFT
